Compressor Overheating

Still Today's Most Serious Field Problem?

By Dave Demma, Senior Application Engineer – Supermarket Refrigeration, Sporlan Division of Parker Hannifin.

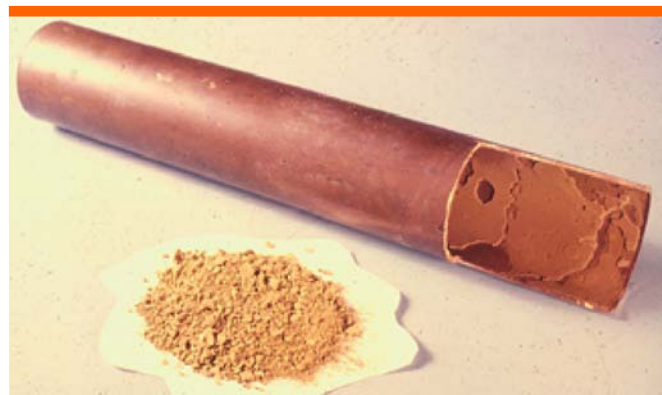
Oil breakdown deposits can also attach themselves to the internal surfaces of the refrigeration system. The inner walls of the piping, compressor, and control valves are all subject to this problem. While this will cause TEVs to stick/plug, and restrict the lubrication passages, oil breakdown on the interior walls of the piping may remain undisturbed for years (Figure 1).

Figure 1 —Oil Breakdown Deposits on Inner Walls of System Piping

Converting a system such as this from R-22/mineral oil to R-404A/POE oil will awaken the oil breakdown like a sleeping giant. With POE’s solvent-like abilities, its presence in the system will literally clean these deposits from the interior surfaces and bring them back into circulation. One can expect contaminant problems after a refrigerant retrofit where the mineral oil has been replaced by POE oil: the new oil that was added to the compressor will likely be dark the next morning, and the odds are that a few TEVs will plug. Several filter-drier/oil filter/oil changes may be necessary before the problem is resolved. While unpleasant, it is simply a natural consequence of excessive discharge temperatures causing oil decomposition, and the solvent-like properties of POE bringing it back into circulation.

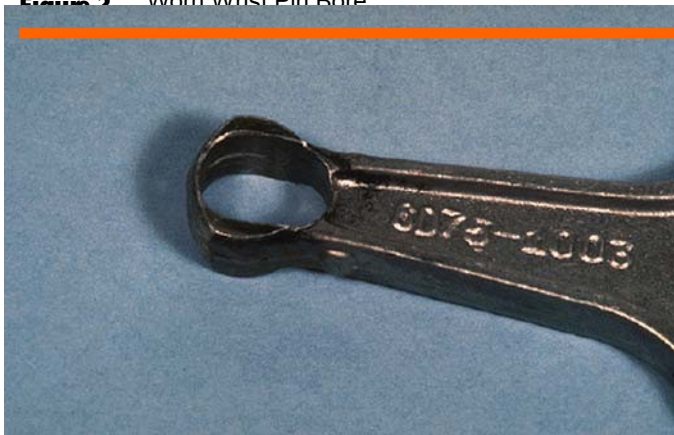
Now, let’s take a look at a real world scenario in how destructive discharge temperatures can be. Most journeymen technicians have heard a compressor operating with what I’ll term a “jackhammer inside the cylinder” syndrome. It is the result of a connecting rod wrist pin bore with excessive wear (Figure 2). The extra play allows the wrist pin to slap against

both ends of the bore. In addition, the piston may hit the bottom of the valve plate at the end of each compression cycle.

Figure 2 — Worn Wrist Pin Bore

Now here is the shocker...this mechanical failure was the result of excessive discharge temperatures. When this system was started, the installing contractor was pressed for time and neglected to set the thermostatic expansion valves (TEV). The resulting high superheat at the evaporator outlets translated into a higher suction superheat at the compressor inlet. For every 1°F increase in the suction temperature an approximate 1°F increase in the discharge temperature will be realized.

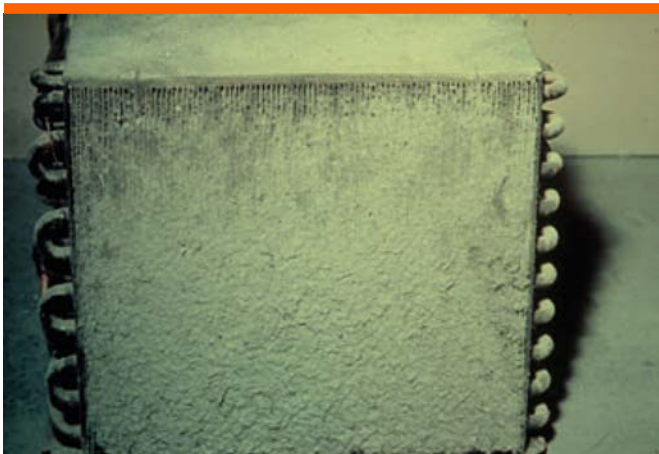
Now jump ahead a year or so. This system is suffering from lack of maintenance in the form of a dirty condenser (Figure 3). The consequence is a higher condensing temperature. According to EPA research, a heat transfer coil with a meager .042" film of dirt on its surface will result in up to a 21% loss of heat transfer capacity.*

Figure 3 — Dirty Condenser

Figure 3 shows an example of this condition; it shows a compressor waiting to fail. Sadly, this is easily...and completely...preventable.

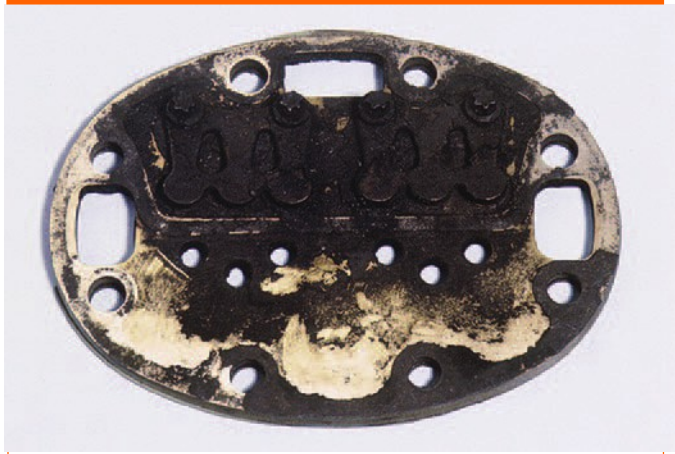
excessive discharge temperatures, and ripe for oil decomposition. After some period of time, what used to be clean looking straw colored oil in the crankcase will become thick and black. Some of this oil breakdown will be deposited on the valve plates (Figure 4), preventing the reed valves from sealing properly.

Figure 4 — Valve Plate with Oil Breakdown Deposits

Clearly, the oil breakdown deposits are the result of high discharge temperatures. Let's see what the full implications are. It starts with a discussion on how the piston wrist pins and their bearings are lubricated.

The oil breakdown is deposited on the discharge reeds, preventing them from seating. Discharge vapor can now leak back into the cylinders during the suction stroke.

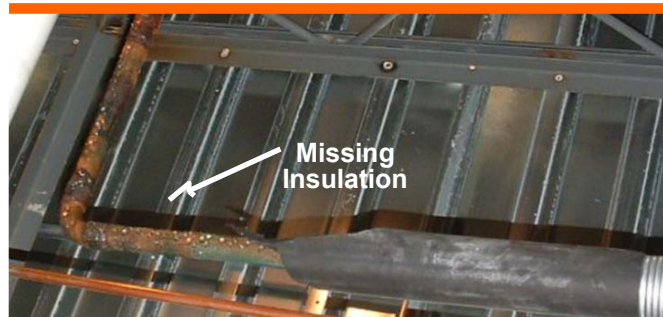
- B. Ineffective or missing insulation (Figure 10).** There may be a temptation to use the lower cost

3/8” wall thickness insulation. This should be avoided. On long piping runs, or where the suction piping is routed through an attic, 1/2” or 1” wall thickness is recommended.

Figure 10 —Missing Suction Line Insulation
